Experimental Research on Rubble Stone Masonry Walls

SUMMARY: This paper refers to the results of a research project carried out at Nova University of Lisbon (Pinho [8]), where several experimental models of rubble stone masonry walls were subjected to axial compression and shear-compression tests. The aim of this research project was the experimental evaluation of some structural strengthening solutions for rubble stone masonry buildings.

Historical Mortars Conference

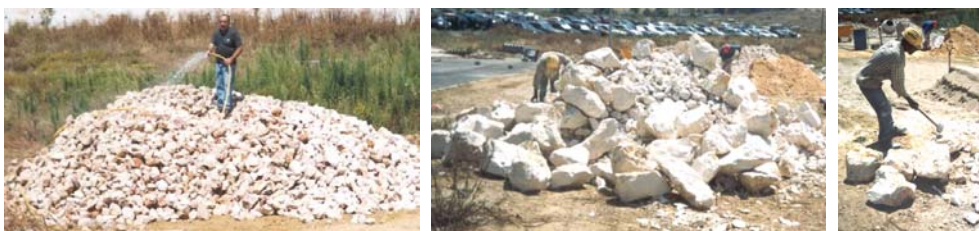
The models were built with stones from Rio Maior. Some of them, with larger dimensions, were used to obtain bigger units than the others, figure 1. These bigger stone blocks were used in general at 1/3 and 2/3 of the height of the experimental models, corresponding to 0,40 m and 0,80 m up to their bases, respectively. These bigger stones are named by “*perpianhos*”. Table 1 present the mean values of the analysed characteristics of stones.

Figure 1 – Preparation of the stones used in the construction the experimental models

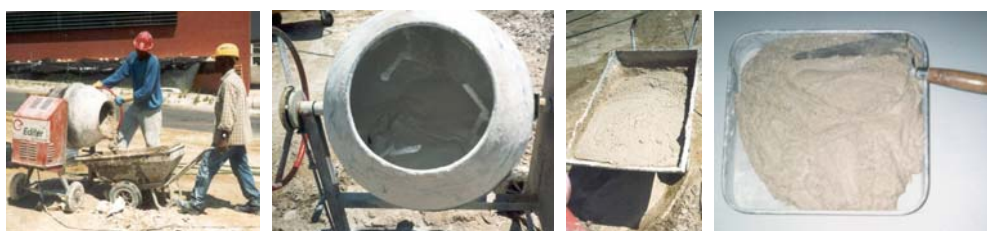
The models were built with lime mortar, using a volumetric composition 1:3 (lime:sand), figure 4. This composition was defined according to researches about the composition of mortars used in Lisbon Pombaline Old Town (Nero [2]) and the analysis of several mortars (Veiga [14]). The ratio water/lime was equal to 1,2, and sands had two origins: river and yellow pit sands, as mentioned in figure 2.

Figure 4 – Lime mortar production using a mechanical mixer

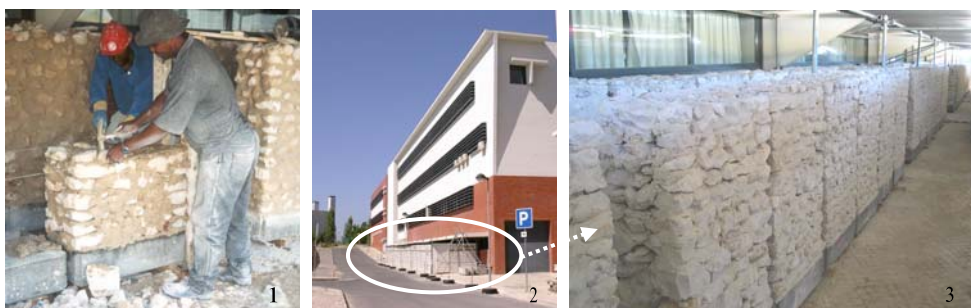
The experimental models of rubble stone masonry were made with 75% of limestone and 25% of lime mortar per m^3 of masonry, figure 7 (Appleton [1], Nero *et al* [6] and Pinho [8, 9]). Sixty two models were constructed using traditional techniques, divided into two groups: 20 models, numbered from 1 to 20, with 1,20m high, 1,20m wide and 0,40m thick, for shear-compression load tests, identified by “large models”, and 42 models, numbered from 21 to 62, with 1,20m high, 0,80m wide and 0,40m thick, to compression load tests, identified by “small models”, according to figure 8 (Pinho [10]).

1 – construction of the experimental models, using traditional techniques; 2 – curing place of the models; 3 – inside of the curing place

Figure 7 – Rubble stone masonry models

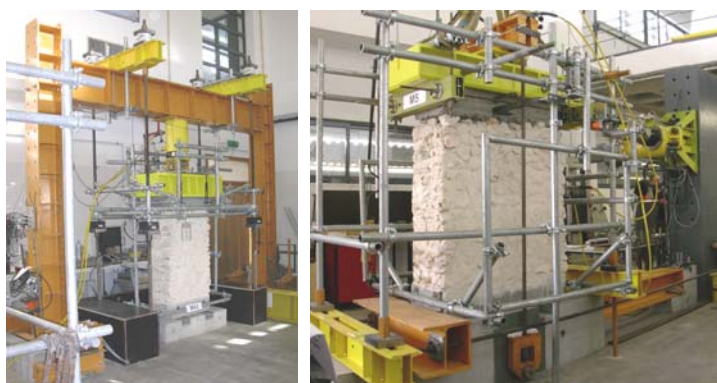
Two different types of loading systems were designed and built up for this research: one for axial compression tests (small models) and another for shear-compression tests (large models), figure 12.

In the axial compression testing system, the load was applied monotonically up to the collapse of the experimental models. The load was applied by a hydraulic cylinder placed between the steel frame and a load spreading steel beam placed over the model. The vertical displacements were measured (on the top of the experimental models) with two LVDTs, fixed to the concrete base of the models.

In the shear-compression testing system the horizontal load was applied monotonically, cyclically or alternately on the tested models. However, the reference models were submitted only to monotonic loading. In this loading system loads were applied in two different phases: first a prescribed vertical load was applied and, subsequently, horizontal displacements were imposed by an actuator standing on a strong wall, till the collapse of the models. The vertical and horizontal displacements were measured with seven LVDTs fixed to the concrete base of the models.

Figure 12 – Axial compression and shear-compression testing systems
